# THE IMPACT OF AGRICULTURAL SETTLEMENT ON CANADIAN SANDY CREEK, OKLAHOMA

**William C. Johnson\*, Hal D. Cantwell†, and Teresa A. Dean#**

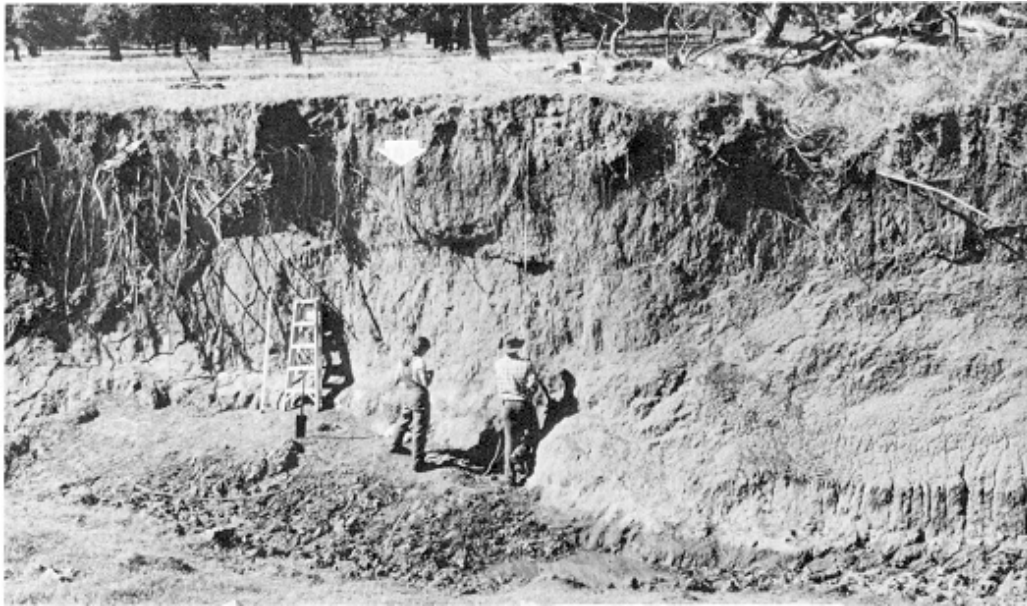
FIGURE 6. A representative bank exposure, which is located at transect two. The white arrow identifies the surface of the presettlement flood-plain soil, which is darker due to increased organic matter content.

A bank exposure typical of Canadian Sandy Creek is illustrated in Figure 6. Approximately 3 feet of post-settlement alluvium occur within the reach shown. Results of sediment analyses from the upper portion of the exposure are presented in Table 1. The former floodplain soil is identified by its finer texture and relatively high organic-matter content, whereas the post-settlement alluvium is generally sandier in texture and lower in organic-matter content.

TABLE 1. *Sediment analyses from the postsettlement and upper presettlement alluvium of the bank exposure shown in Figure 6.*
